**Flood Control Project Maintenance
Levee Inspections**

Fall 2011 Levee Maintenance Deficiency Summary Report

Sutter Maintenance Yard East Levee Sacramento River

Levee Inspection Report By Mile - Fall 2011

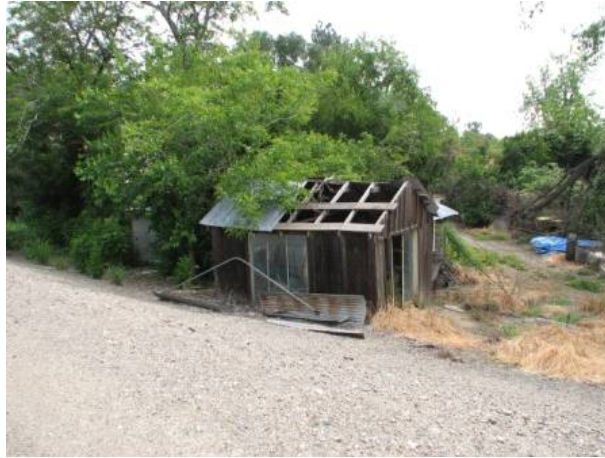
Levee Mile Report Line	1
Start Levee Mile	0.08
End Levee Mile	0.14
Location	Water Side
Category	Earthen Levee
Item	Encroachments

View of a old building next to the landside toe.

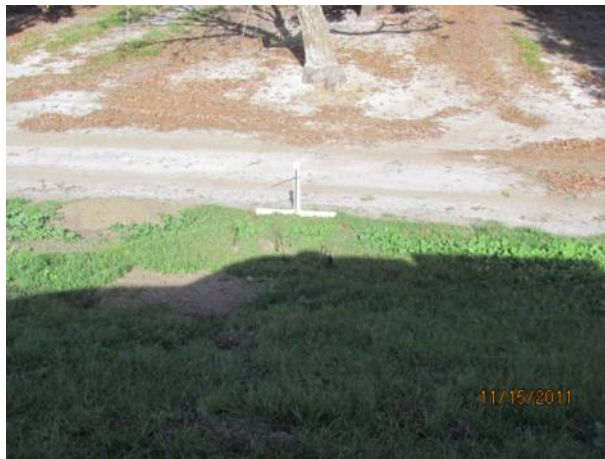
Levee Mile Report Line	2
Start Levee Mile	2.05
End Levee Mile	2.05
Location	Land Side
Category	Earthen Levee
Item	Animal Control

View of the rodent holes & bait station.

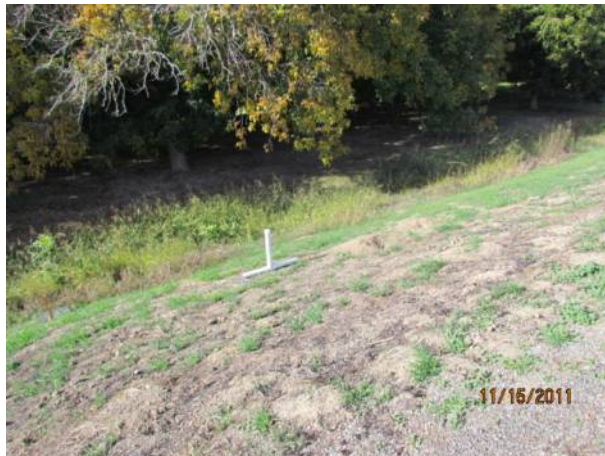
Levee Mile Report Line	3
Start Levee Mile	3.03
End Levee Mile	3.03
Location	Water Side
Category	Earthen Levee
Item	Animal Control

View of the rodent holes & bait station.

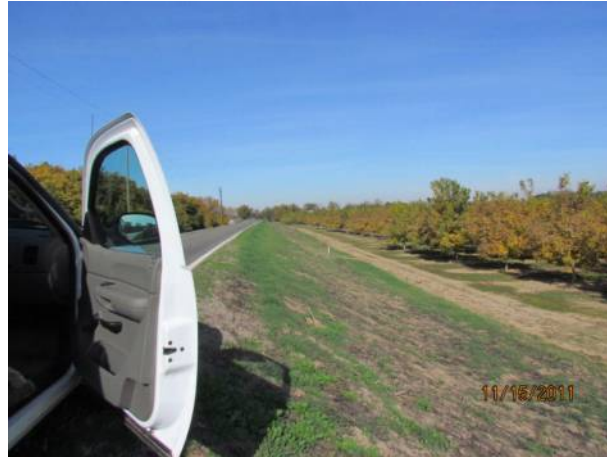
Levee Mile Report Line	4
Start Levee Mile	3.06
End Levee Mile	3.12
Location	Land Side
Category	Earthen Levee
Item	Animal Control

View of the rodent holes & bait station.

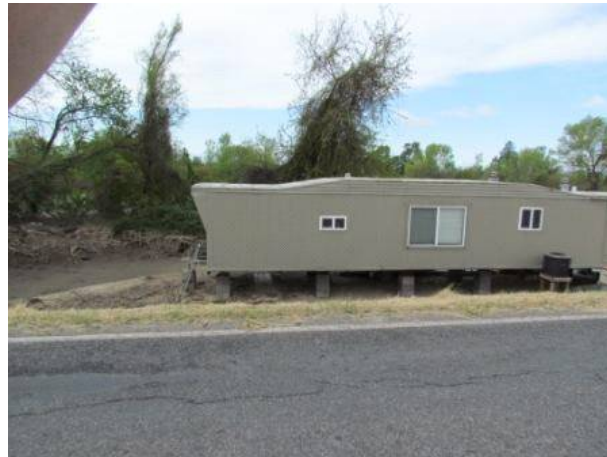
Levee Mile Report Line	5
Start Levee Mile	4.19
End Levee Mile	4.19
Location	Water Side
Category	Earthen Levee
Item	Encroachments

View of the trailer next to the W/S toe.

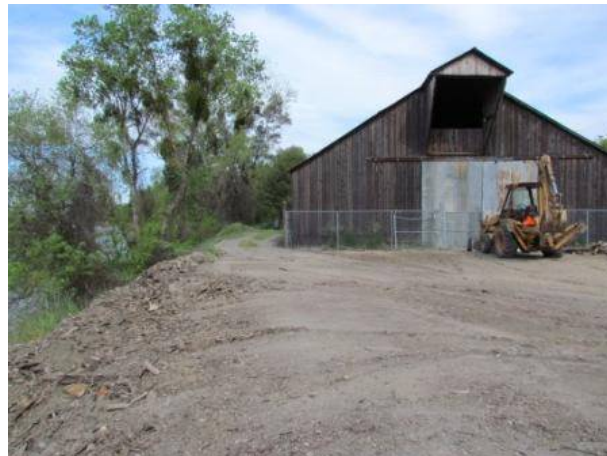
Levee Mile Report Line	6
Start Levee Mile	4.66
End Levee Mile	4.84
Location	Crown
Category	Earthen Levee
Item	Encroachments

View of the barn on the large crown of the levee.

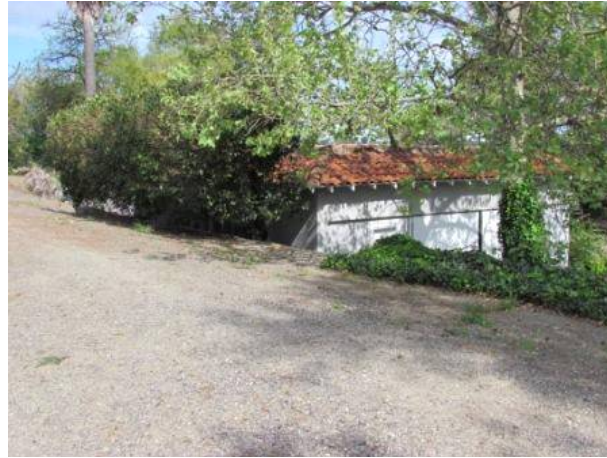
Levee Mile Report Line	9
Start Levee Mile	4.81
End Levee Mile	4.81
Location	Land Side
Category	Earthen Levee
Item	Encroachments
View of the building next to the L/S toe.	
rduffey_f_20110927_220.jpg

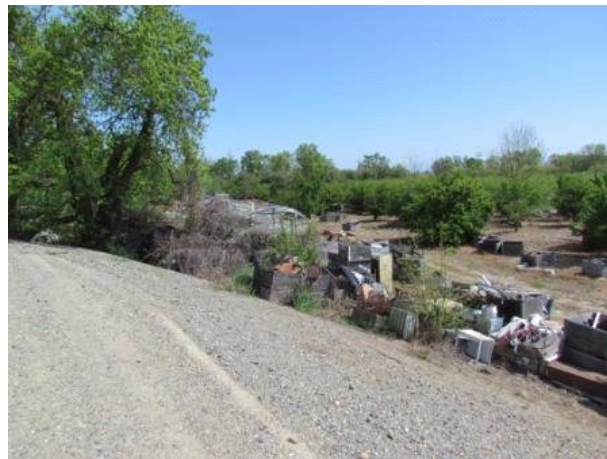
Levee Mile Report Line	14
Start Levee Mile	6.42
End Levee Mile	6.42
Location	Land Side
Category	Earthen Levee
Item	Encroachments
View of the material & garbage along the toe.	
rduffey_f_20110927_221.jpg

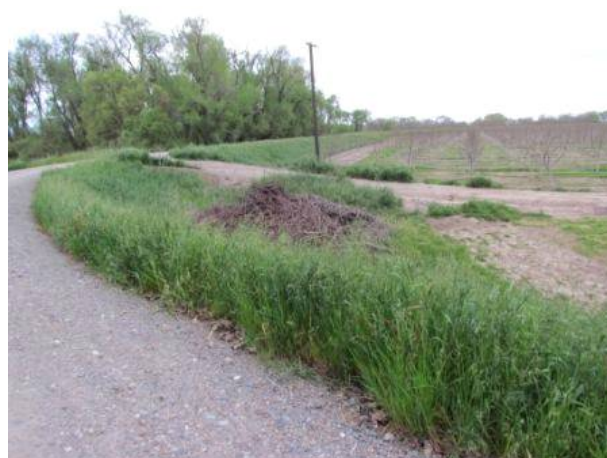
Levee Mile Report Line	16
Start Levee Mile	9.23
End Levee Mile	9.23
Location	Land Side
Category	Earthen Levee
Item	Encroachments
View of the prunings along the L/S toe.	
rduffey_f_20110927_214.jpg

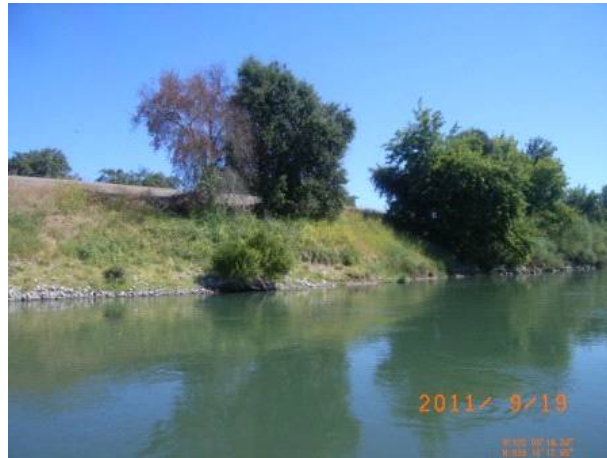
USACE 2011 Photo #1

Levee Mile Report Line	19
Start Levee Mile	10.47
End Levee Mile	10.64
Location	Water Side
Category	Supplemental
Item	USACE Erosion Survey

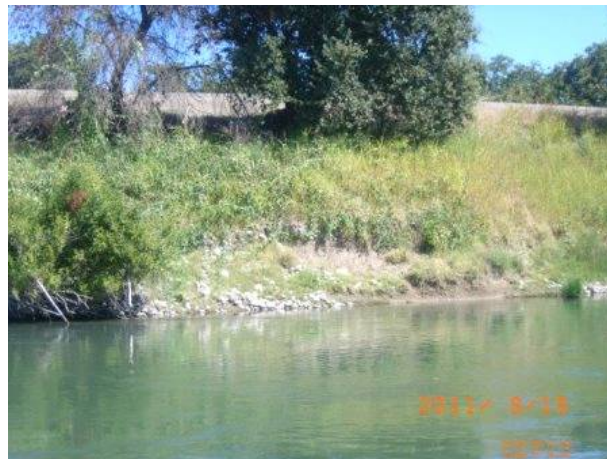
USACE 2011 Photo #2

Levee Mile Report Line	19
Start Levee Mile	10.47
End Levee Mile	10.64
Location	Water Side
Category	Supplemental
Item	USACE Erosion Survey

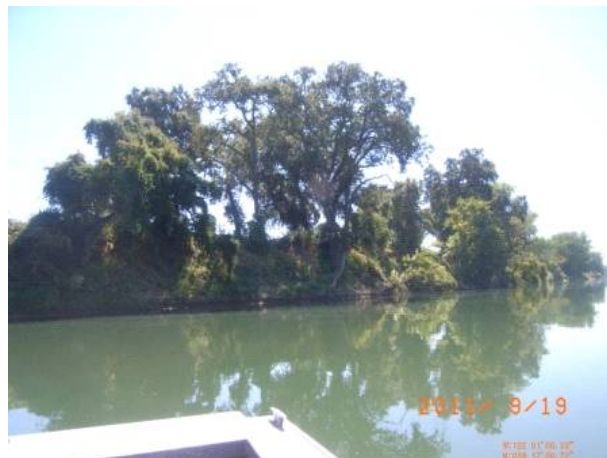
USACE 2011 Photo #1

Levee Mile Report Line	20
Start Levee Mile	11.51
End Levee Mile	11.77
Location	Water Side
Category	Supplemental
Item	USACE Erosion Survey

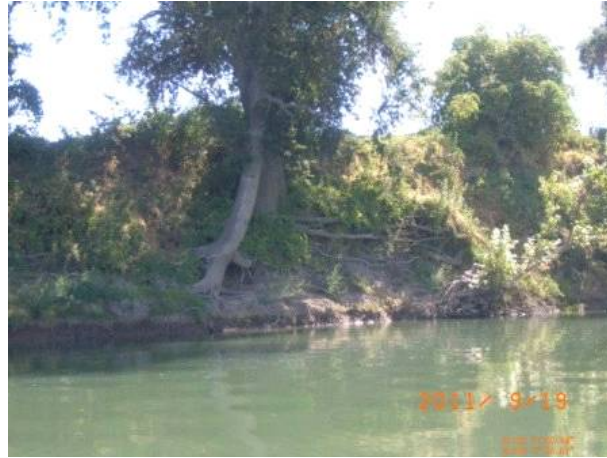
USACE 2011 Photo #2

Levee Mile Report Line	20
Start Levee Mile	11.51
End Levee Mile	11.77
Location	Water Side
Category	Supplemental
Item	USACE Erosion Survey

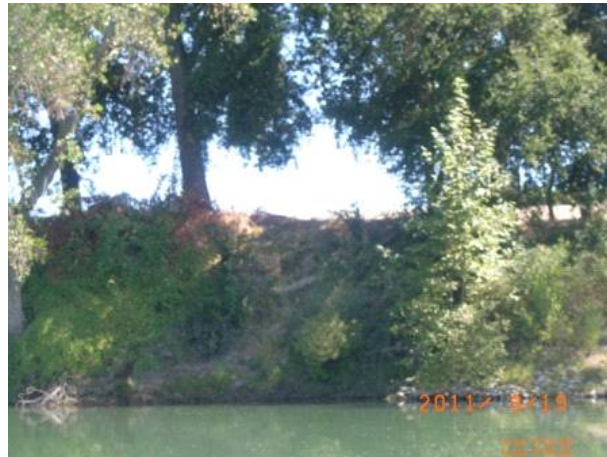
USACE 2011 Photo #3

Levee Mile Report Line	20
Start Levee Mile	11.51
End Levee Mile	11.77
Location	Water Side
Category	Supplemental
Item	USACE Erosion Survey

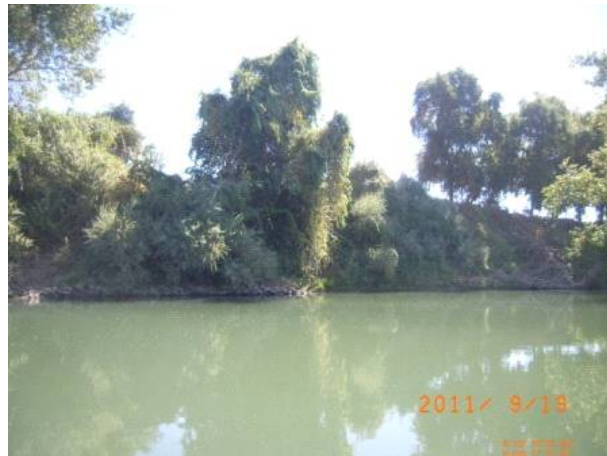
USACE 2011 Photo #1

LMR No.	Levee Mile		Category	Item	Location *	Rating **	Action/Comment	GPS Latitude/Longitude		Issue No.
	Start	End						Start	End	
19	10.47	10.64	Supplemental	USACE Erosion Survey	WS	M	Inspector Comments: 2009 - Toe erosion and sliding cobbles. 2011: No observed change. [2011 Site ID: SAC_150-2_L]	39.271494 ° -122.003497 °	39.271307 ° -122.003295 °	27 Y
20	11.51	11.77	Supplemental	USACE Erosion Survey	WS	M	Inspector Comments: 2008 - Large rotational/mass failure in the bank with tree slump. 2009 - Minimal new erosion, the tree is leaning further into the river. 2011: Site extended downstream. [2011 Site ID: SAC_152-6_L]	39.279910 ° -122.018221 °	39.283853 ° -122.016113 °	28 Y
21	11.67	11.90	Earthen Levee	Encroachments	LS	PO	Agricultural Ditch	39.282064 ° -122.016517 °	39.285084 ° -122.014815 °	6
22	11.81	11.83	Supplemental	USACE Erosion Survey	WS	M	Inspector Comments: 2006 - Large rotational/mass failure in the bank with tree slump. Tough clayey toe material. 2007 - Site is between stone revetments with a pump station at the downstream end. 2010 - Erosion is into the levee toe. 2011: Minor new erosion. [2011 Site ID: SAC_152-8_L]	39.285298 ° -122.015208 °	39.284568 ° -122.015690 °	29 Y

Levee Mile Report Line	22
Start Levee Mile	11.81
End Levee Mile	11.83
Location	Water Side
Category	Supplemental
Item	USACE Erosion Survey

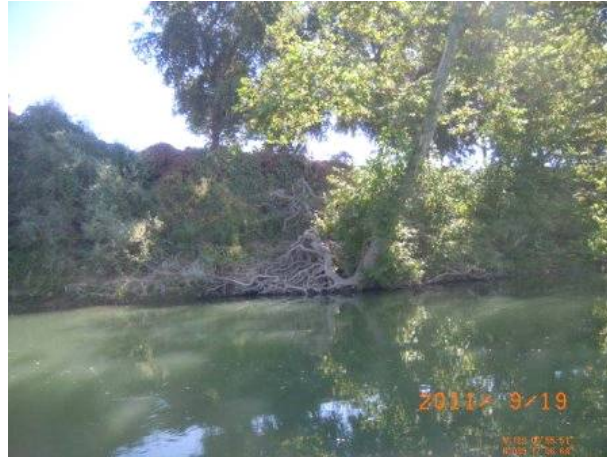
USACE 2011 Photo #2

Levee Mile Report Line	22
Start Levee Mile	11.81
End Levee Mile	11.83
Location	Water Side
Category	Supplemental
Item	USACE Erosion Survey

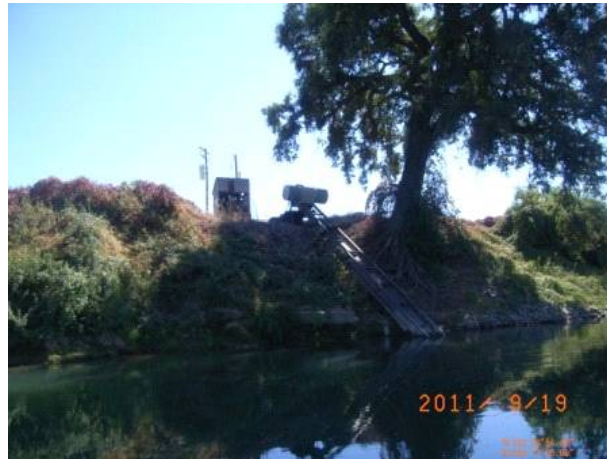
USACE 2011 Photo #3

Levee Mile Report Line	22
Start Levee Mile	11.81
End Levee Mile	11.83
Location	Water Side
Category	Supplemental
Item	USACE Erosion Survey

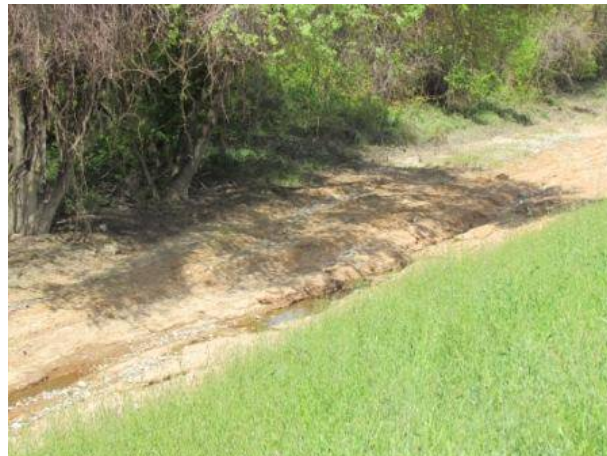
Levee Mile Report Line	24
Start Levee Mile	13.47
End Levee Mile	13.66
Location	Water Side
Category	Earthen Levee
Item	Erosion / Bank Caving

View of the erosion along the W/S toe.

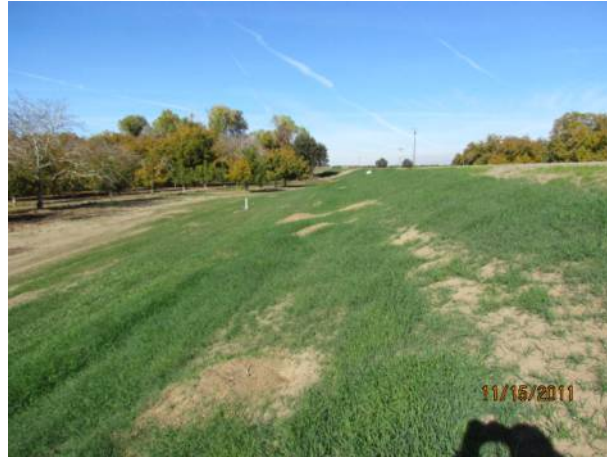
Levee Mile Report Line	25
Start Levee Mile	13.87
End Levee Mile	13.87
Location	Water Side
Category	Earthen Levee
Item	Animal Control

View of the rodents hole along the W/S slope.

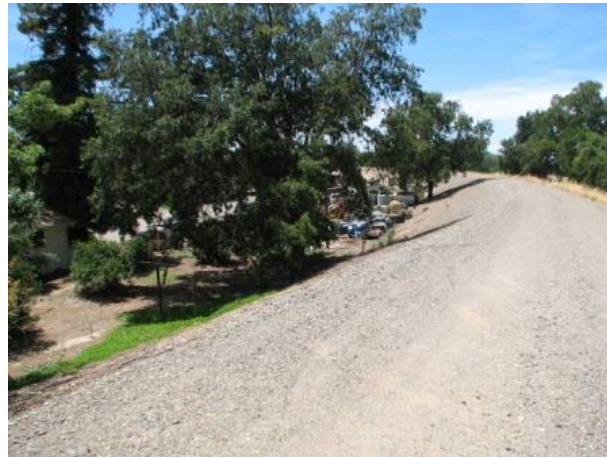
Levee Mile Report Line	28
Start Levee Mile	18.04
End Levee Mile	18.18
Location	Land Side
Category	Earthen Levee
Item	Encroachments

View of the equipment and trees next to the landside toe of the levee.

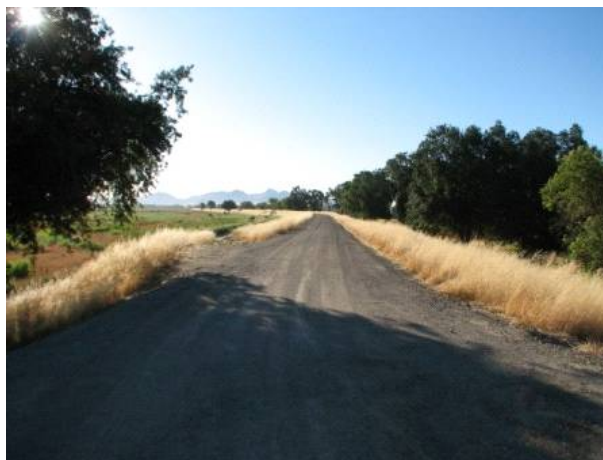
Levee Mile Report Line	1
Start Levee Mile	0.01
End Levee Mile	0.01
Location	Land Side
Category	Earthen Levee
Item	Vegetation

View of the elderberries along the landside toe of the levee.

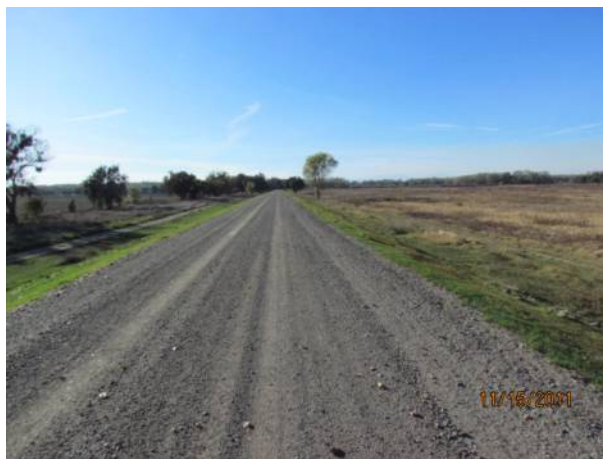
Levee Mile Report Line	2
Start Levee Mile	0.61
End Levee Mile	0.61
Location	Land Side
Category	Earthen Levee
Item	Vegetation

View of both levee slopes.

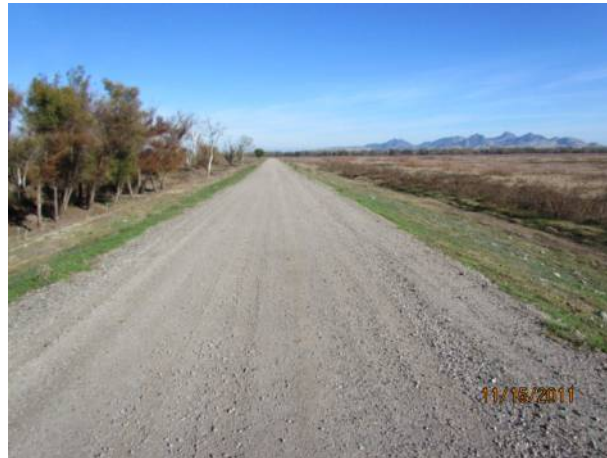
Levee Mile Report Line	2
Start Levee Mile	0.58
End Levee Mile	0.94
Location	Crown
Category	Earthen Levee
Item	Crown Surface / Depressions / Rutting
Sutter Yard placed new gravel on the crown roadway.	
rduffey_f_20111121_496.jpg

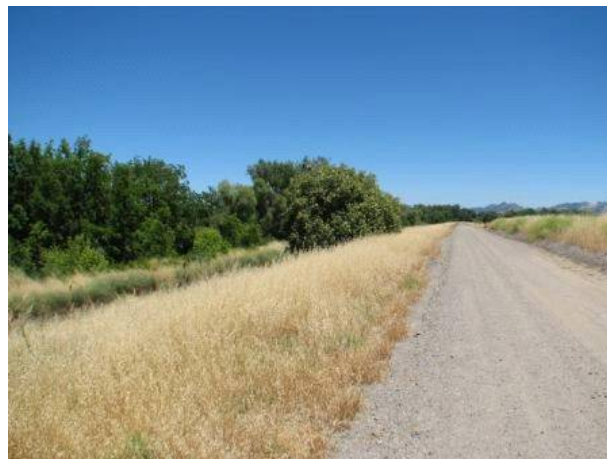
Levee Mile Report Line	3
Start Levee Mile	1.98
End Levee Mile	1.98
Location	Land Side
Category	Earthen Levee
Item	Vegetation
View of the elderberries along the landside toe of the levee.	
rduffey_f_20110927_225.jpg

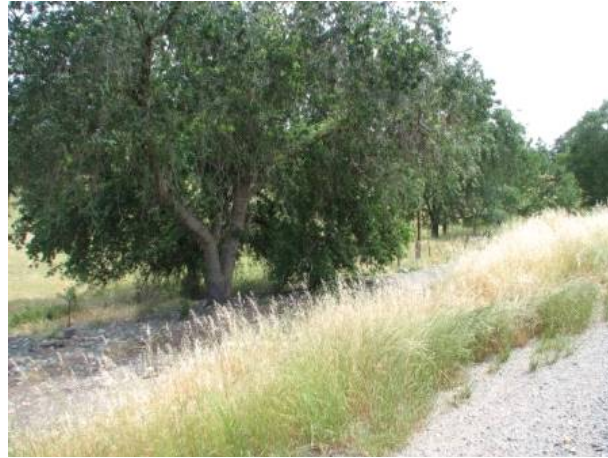
View of a Elderberries bush by the waterside toe.

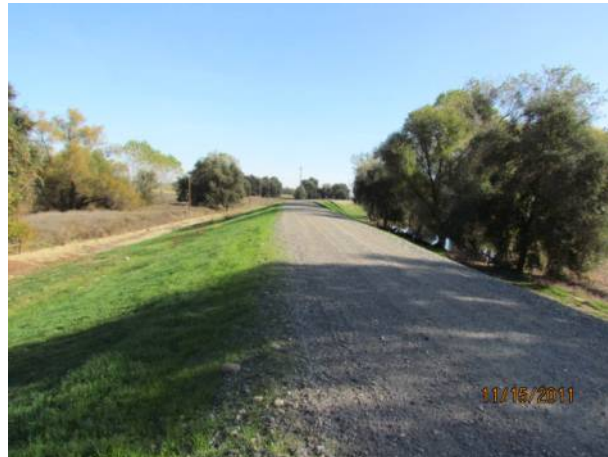
Levee Mile Report Line	2
Start Levee Mile	0.05
End Levee Mile	0.05
Location	Land Side
Category	Earthen Levee
Item	Vegetation

View of both levee slopes.

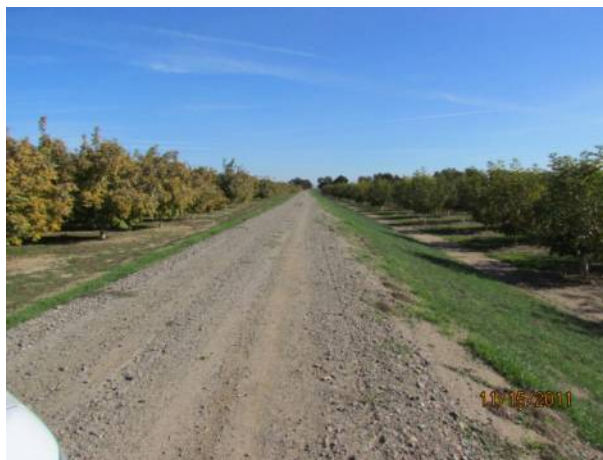
View of the levee slopes.

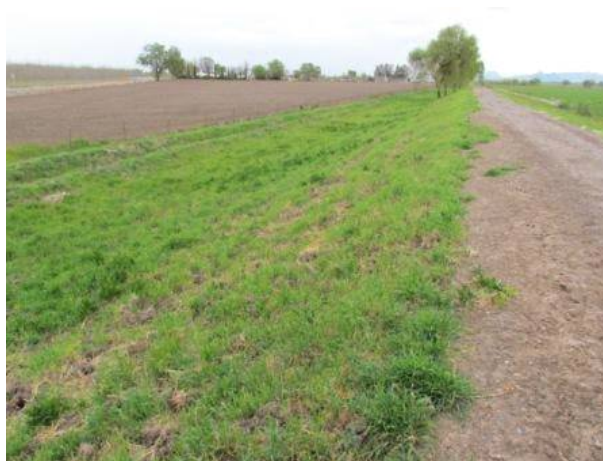
Levee Mile Report Line	2
Start Levee Mile	0.79
End Levee Mile	1.58
Location	Land Side
Category	Earthen Levee
Item	Animal Control

View of the levee slopes damaged by livestock.

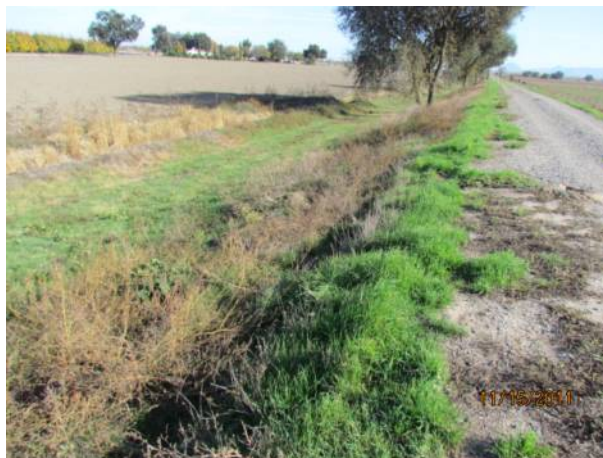
Levee Mile Report Line	3
Start Levee Mile	0.85
End Levee Mile	0.85
Location	Land Side
Category	Earthen Levee
Item	Animal Control

View of the rodents hole along the L/S slope.
